NBS BUILDING SCIENCE SERIES 145

Investigation of Construction Failure of Harbour Cay Condominium in Cocoa Beach, Florida

Based on the results of this investigation, it is concluded that the most probable cause of the failure was insufficient punching shear capacity in the fifth-floor slab to resist the applied construction loads.

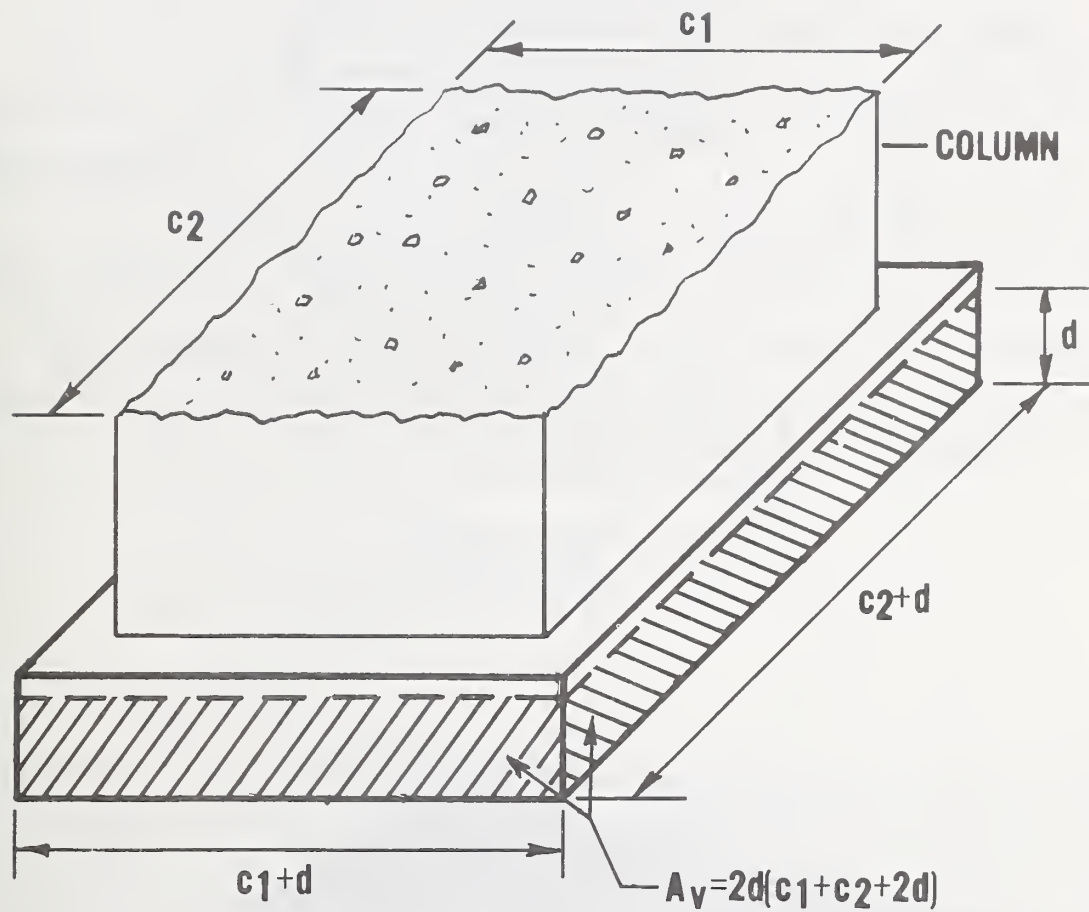
Figure 2.6 Area of critical section for punching shear

The importance placed on actual chair heights and their location is due to the fact that the effective depth of the slab is a critical parameter governing its punching shear and bending capacity. Figure 2.6 defines the critical shear area used in calculations of punching shear stresses in the slab at the periphery of a column. The punching shear area depends on the sectional dimensions c_1 and c_2 of the column and the effective depth, d , which appears in all three dimensions defining this area.

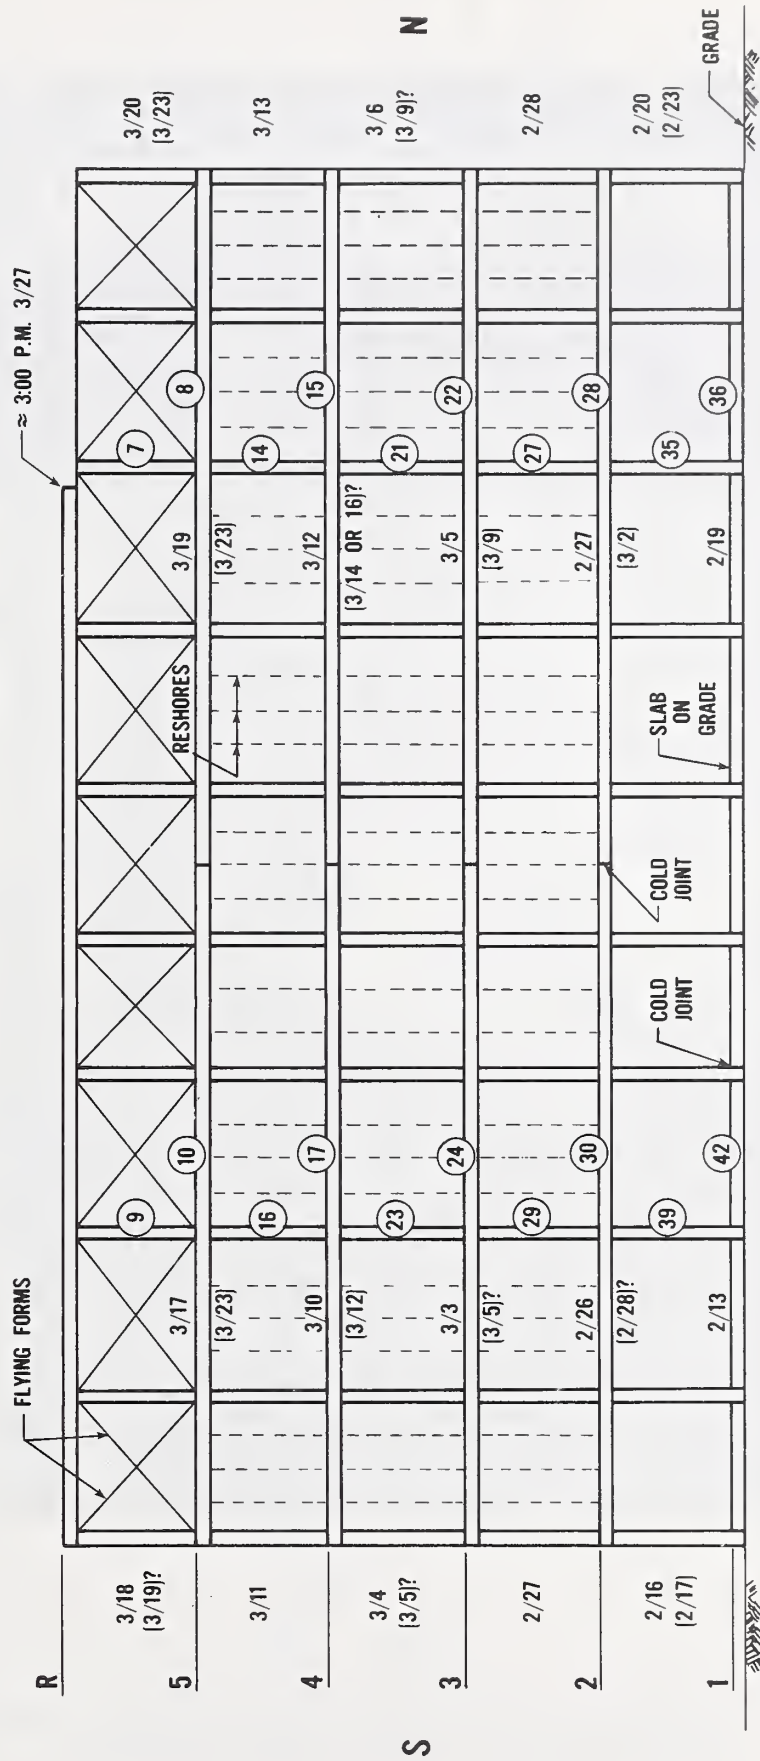
Figure 2.11 Assumed state of construction at time of the collapse

Figure 2.11 shows the various casting and stripping dates and the ages of the columns and floor slabs relative to the time of the collapse. In the case of incomplete information or conflicting witness statements regarding the date of a particular event, a question mark appears next to the specified date in the figure. Note that, unlike the lower story slabs, the roof slab was scheduled to be cast in one day. At the time of the collapse, all but the two north bays of the roof slab had been cast.

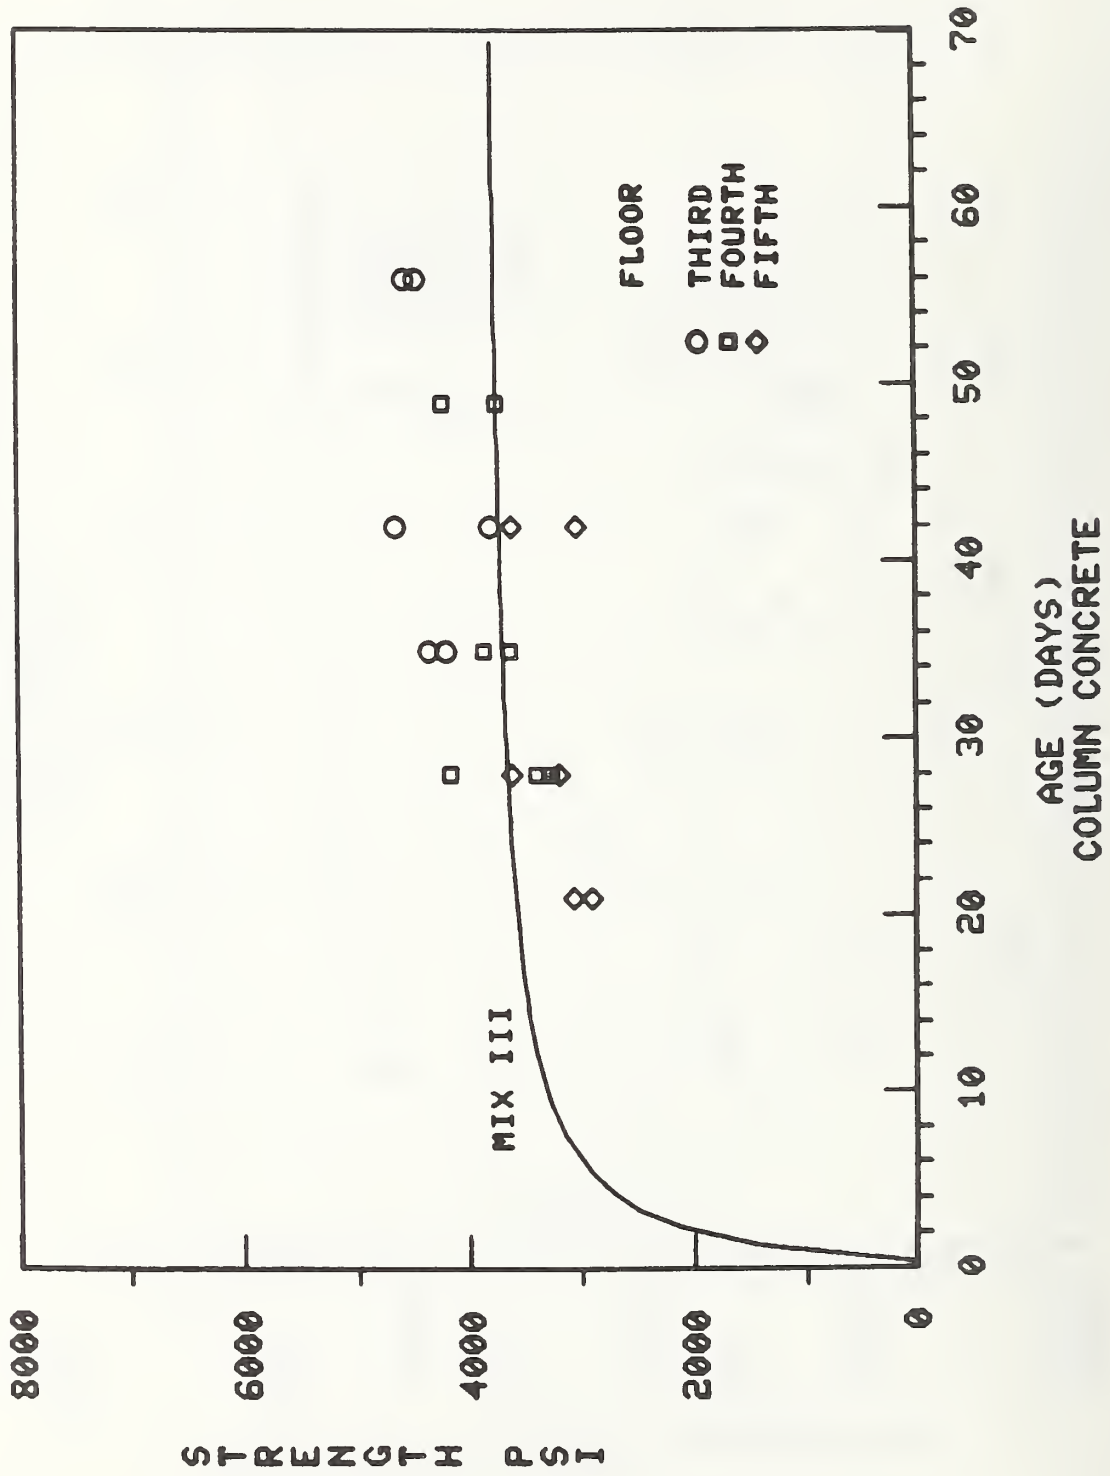
Figure 4.7 Comparison of strength of cores from columns with the laboratory mix

Figure 4.7 compares Mix III with the column core strengths. The laboratory mix is consistent with these core tests.

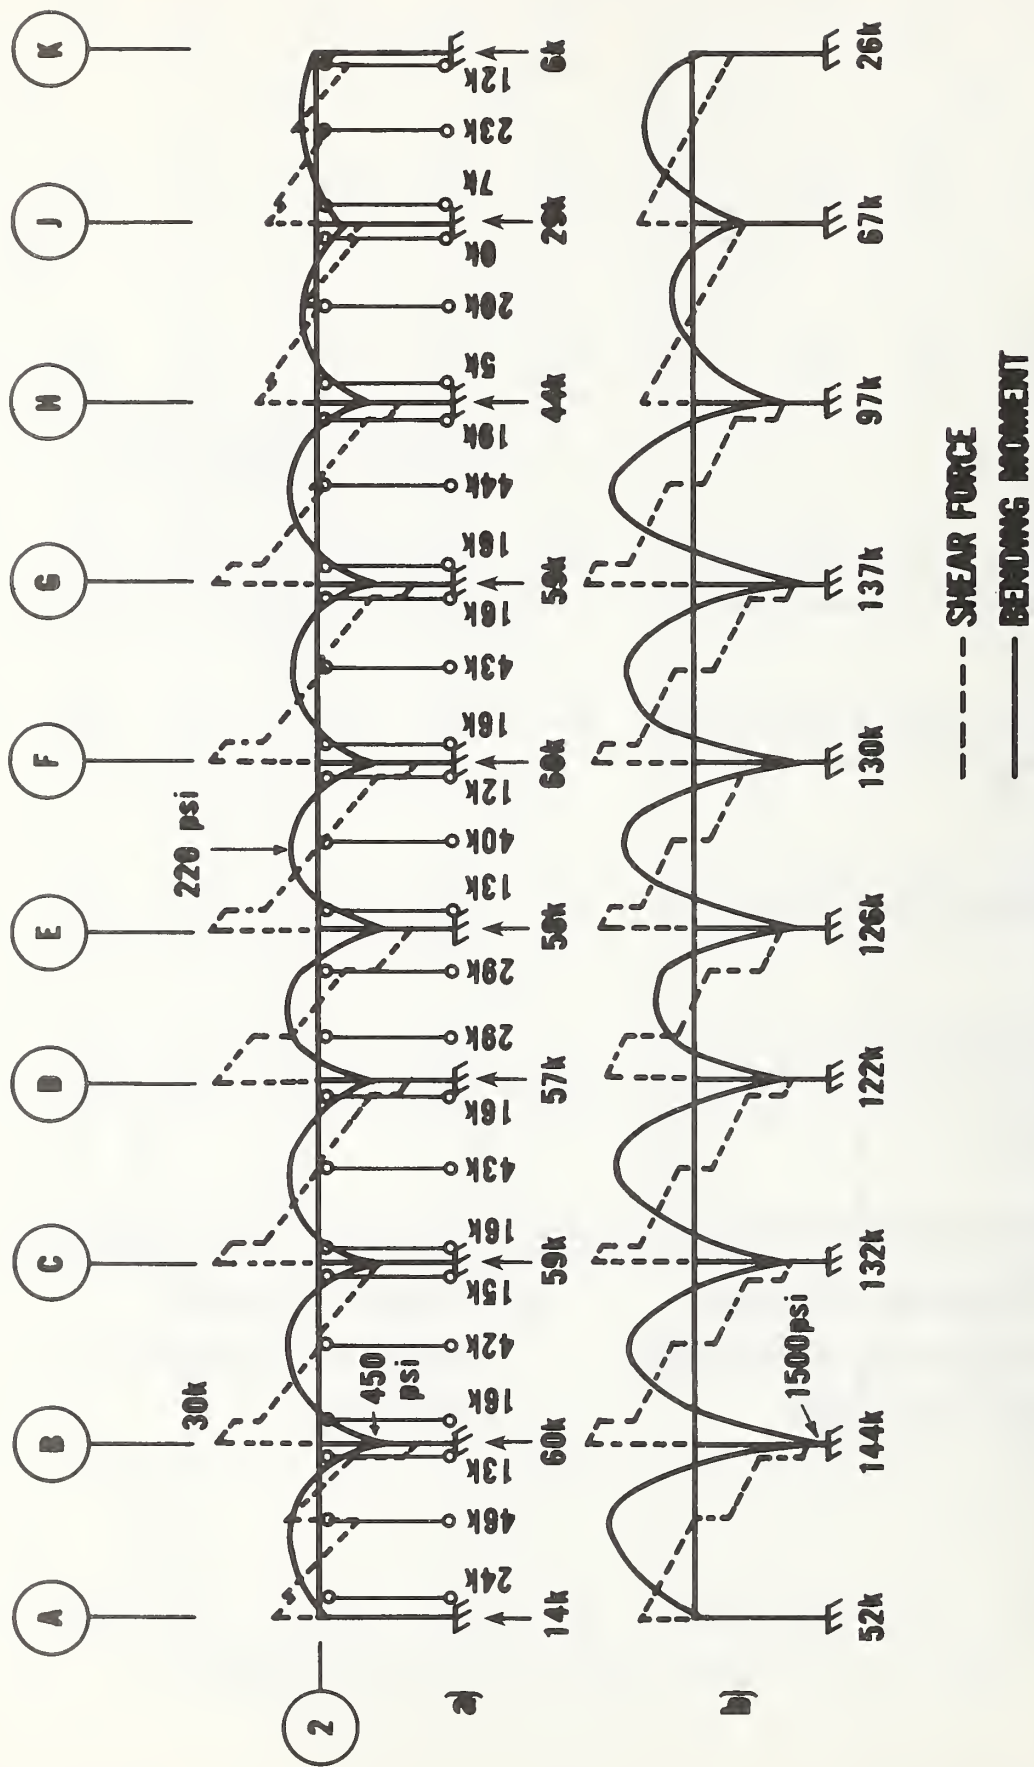
Figure 5.5 Results of FEM analysis of fifth floor only

forces in columns on column line 2 with those obtained from the EFM analysis (fig. 5.5a) shows poor agreement between the two sets of results.

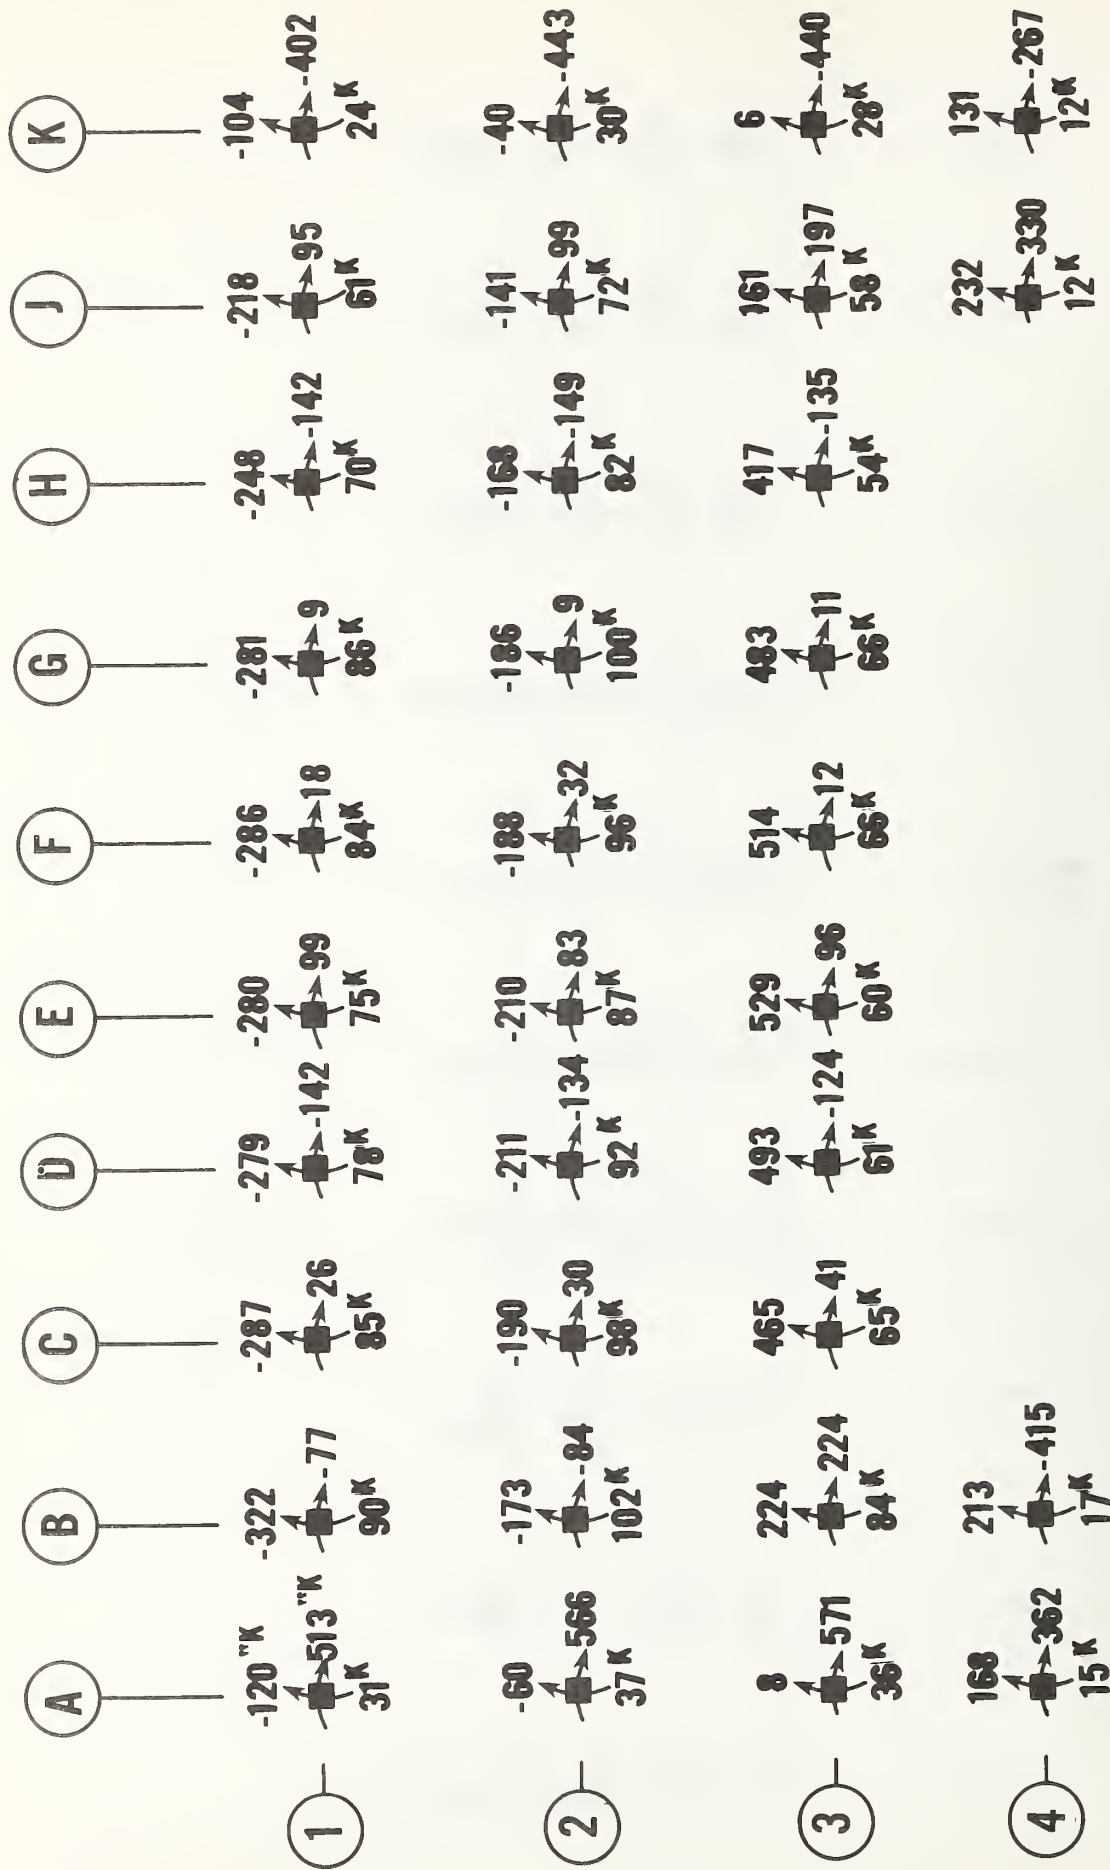
Figure 5.13 Fifth floor punching shear and column moments

- 4) In order to account for the three-dimensional response of the shored structure, the finite element method was used for the final analysis.
- 5) The results of the analysis indicate that the most heavily loaded slab-column connections are in the fifth floor at columns B-2 and G-2.

To verify that such a failure had occurred, punching shear stresses resulting from direct shear forces and unbalanced moments were computed at slab-column connections using the shear and moment values for construction loads given in figure 5.13. These shear stress values were compared with the shear capacity of the slab based on the predicted in-place strength of concrete at the time of collapse. Because the punching shear stress values are maximum at the fifth floor level (see figures 5.12 and 5.13), the shear stresses are evaluated only for this level. The guidelines given in the ACI Code [2.1] are followed in computing the punching shear stress. Figure 6.1(a) shows the critical section in the slab around an interior column. The critical section where shear stresses are evaluated is taken perpendicular to the plane of the slab and a distance a half of the effective depth away from the periphery of the column.

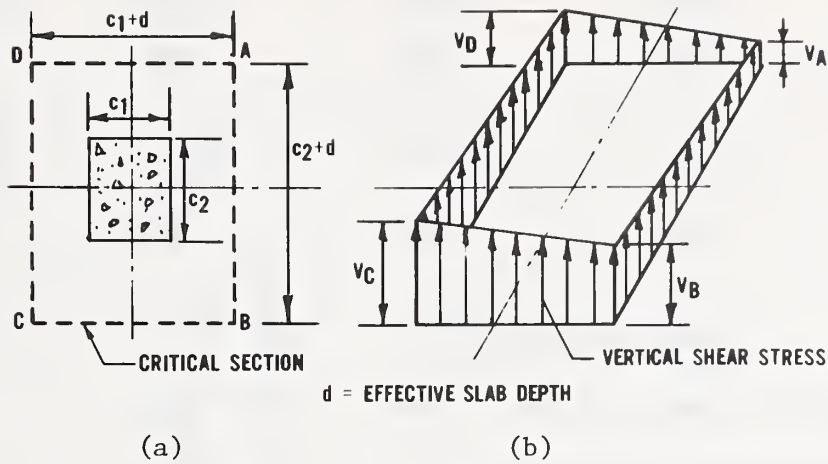
Figure 6.1 Shear stress distribution at interior column

The assumed distribution of shear stresses at the critical section is shown in figure 6.1(b). The critical sections for edge and corner columns and corresponding assumed shear stress distributions at these critical sections are shown in figure 6.2(a) and (b) and figure 6.3(a) and (b), respectively.
